National Transportation Safety Board Aviation Accident Final Report

Location:	Superior, AZ	Accident Number:	WPR16FA040
Date & Time:	12/15/2015, 1723 MST	Registration:	N74317
Aircraft:	AIRBUS Helicopters AS350	Aircraft Damage:	Substantial
Defining Event:	Low altitude operation/event	Injuries:	2 Fatal, 1 Serious
Flight Conducted Under:	Part 135: Air Taxi & Commuter - Non-scheduled - Air Medical (Discretionary)

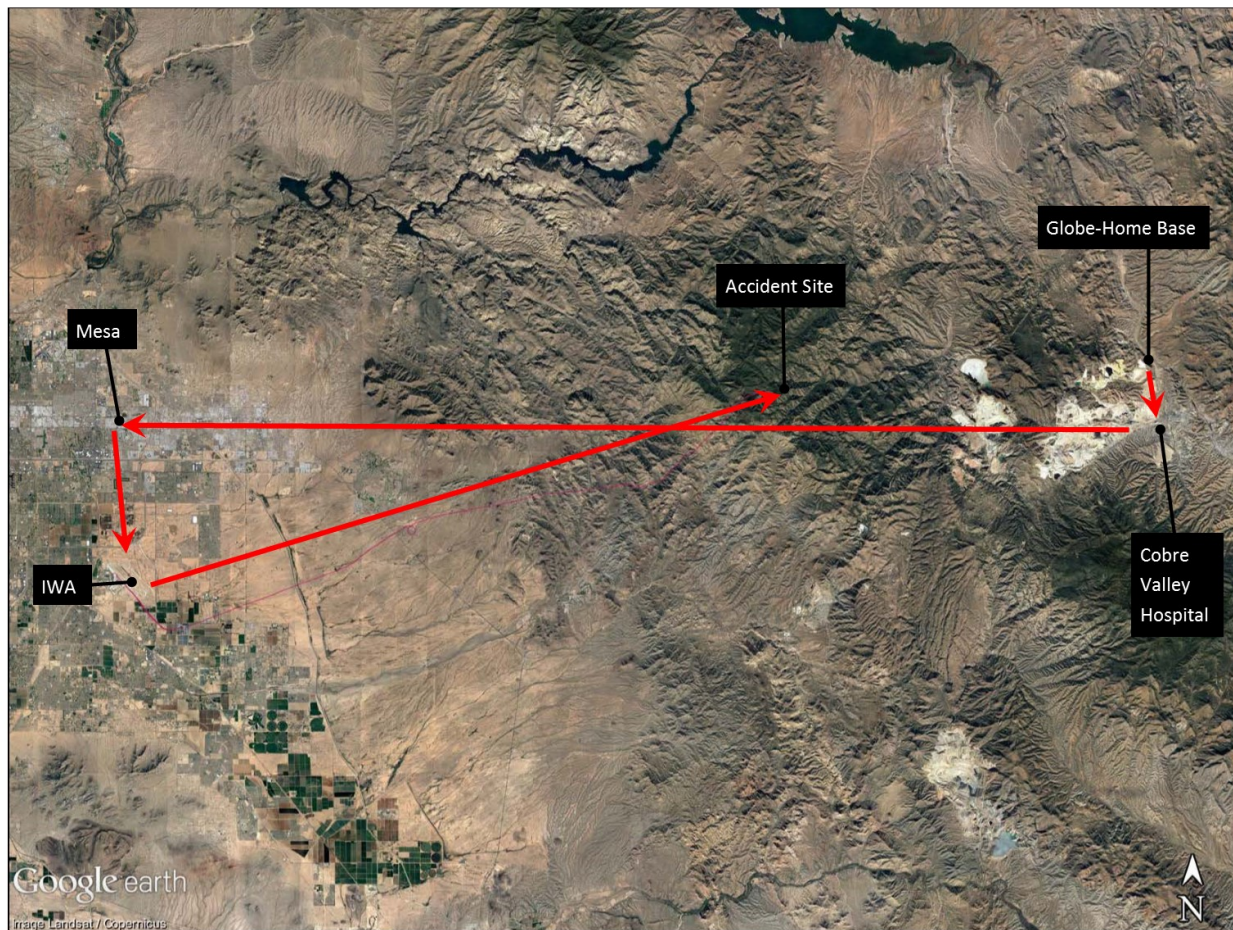
Figure 1-Overview of Flights

According to the operator, the helicopter was based in Globe and had transported a patient from the Cobre Valley Community Hospital in Globe to the Baywood Heart Hospital in Mesa. After transporting the patient, the pilot flew the helicopter to IWA for refueling before the return flight to Globe. (See figure 1)

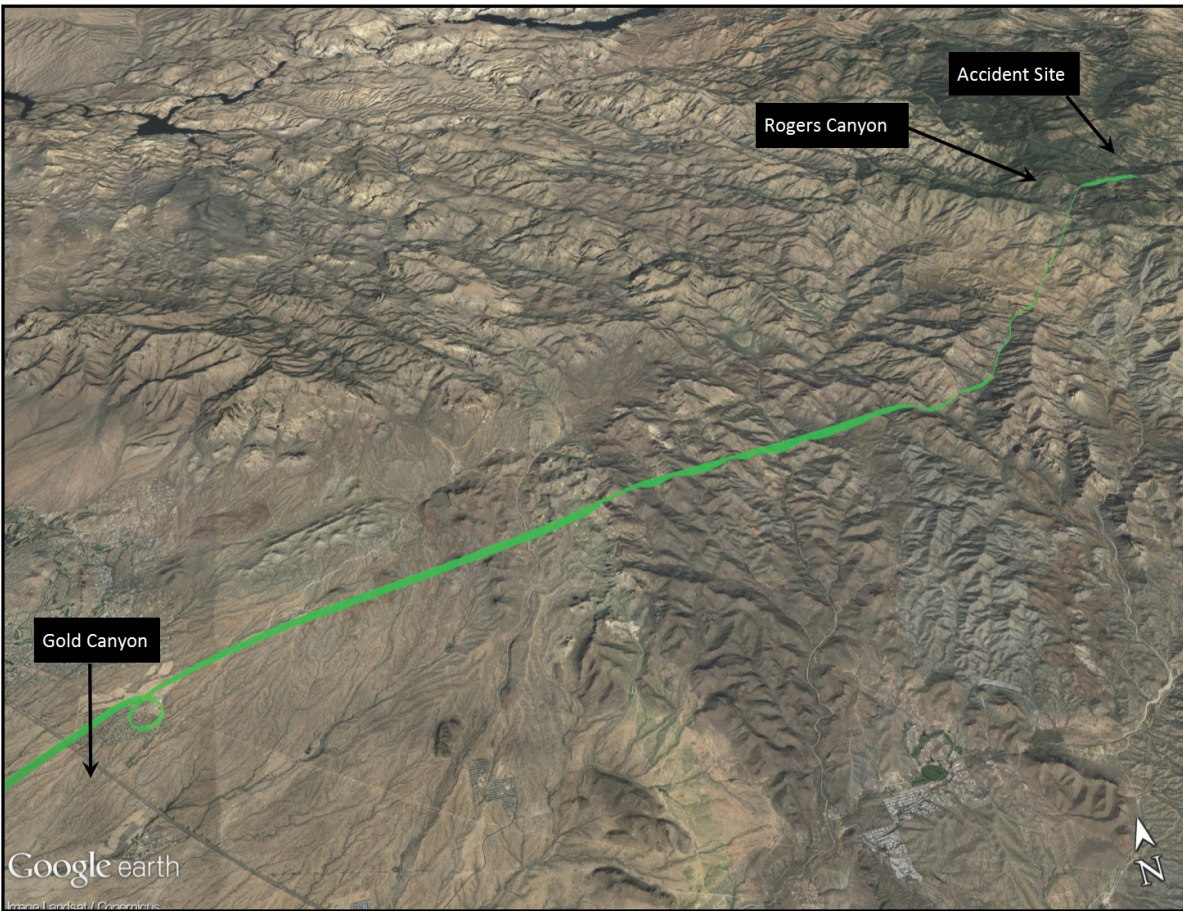
Figure 2-Aerial View of Accident Flight

About 1719, the helicopter entered mountainous terrain, and the height of the helicopter above the terrain began to vary as the terrain elevation rose and fell. Between 1718 and 1720, the altitude varied between 240 ft agl and 1,150 ft agl. Between 1720 and the end of the flight, the altitude varied between 30 ft agl and 770 ft agl. About 1721, the helicopter turned from a heading of about 80° to a heading of about 45° and followed a canyon beneath its ridgelines. (See figure 2)

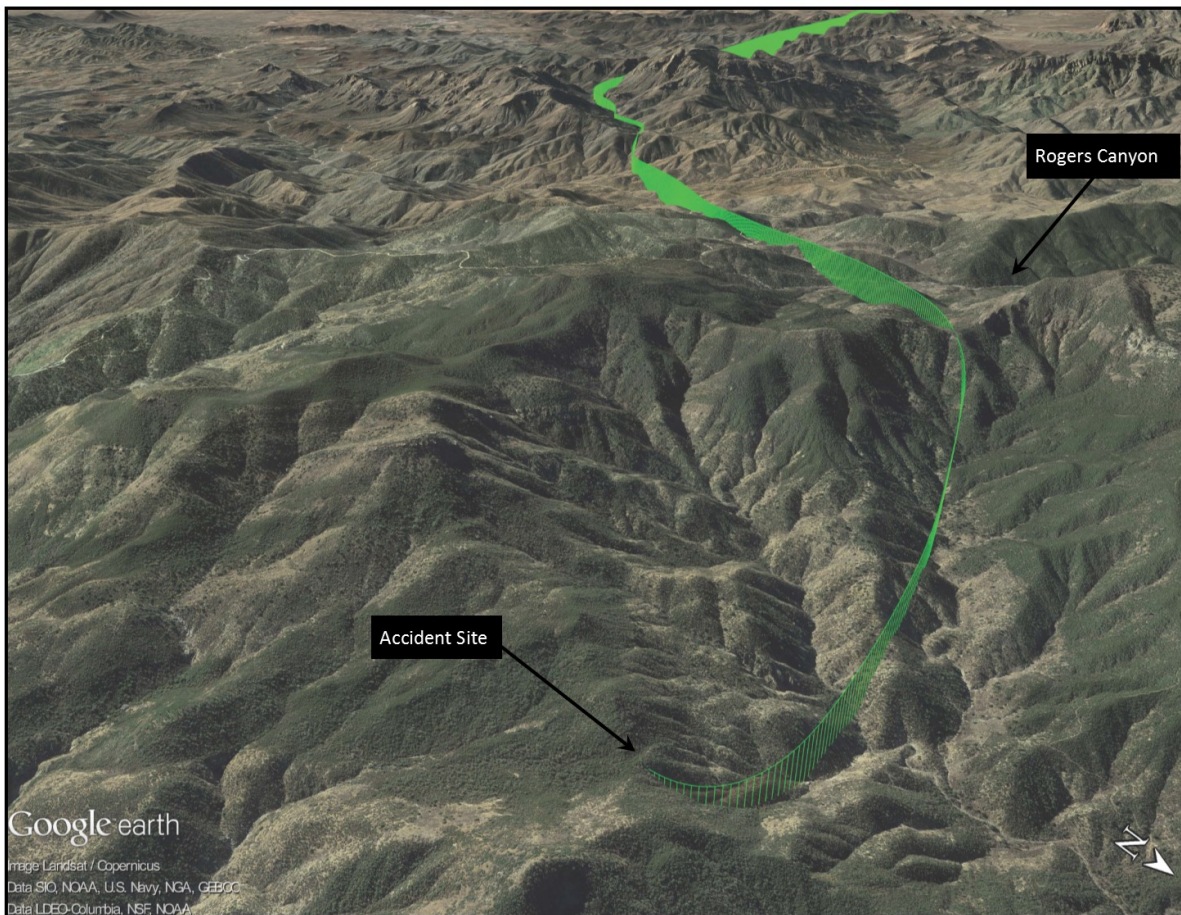
Figure 3-Aerial View of the Accident Flight and Accident Flight

The helicopter flew nearly perpendicularly over the north-south oriented Rogers Canyon, and at 1723:07, it continued through a saddle on the canyon's east wall, clearing the terrain by about 30 ft. As it passed over the eastern ridgeline, the helicopter banked to the right, changing from a ground track of about 43° to 76°, and reached a ground speed of about 120 knots. After the helicopter cleared the ridge, it started to descend and accelerate. The ground speed reached a maximum of 148 knots at 1723:21. The helicopter banked right (about 5° to 10° of roll), and its heading changed from 76° at 1723:18 to about 90° at 1723:32. (See figure 3)
